# BEN LOMOND FIRE PROTECTION DISTRICT

## AGENDA of the BOARD OF DIRECTORS

Wednesday October 16, 2024 at 9:00 AM

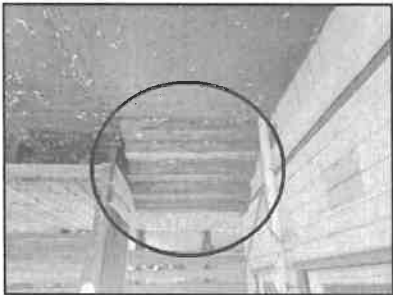
1.1 Item 1 (Picture)

Exterior stairway height varies more than 3/8 of an inch. Noted on various stairs around the home. Improper rise or run was noted at the stairs. This means that one or more of the stairs was higher or longer than the others or that the length of the stairs does not meet current standards. This should be considered a tripping hazard and correction is recommended.

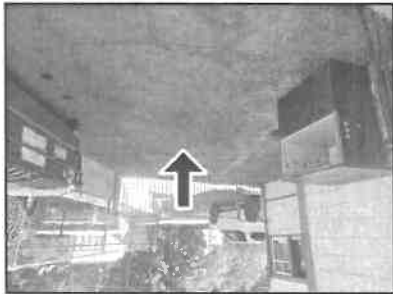
1.2 Item 2 (Picture)

Asphalt seal coat / general maintenance needed. The driveway is in need of repairs. Proper maintenance will extend the life of the asphalt driveway. Recommend the driveway be patched or replaced as needed and then sealed.

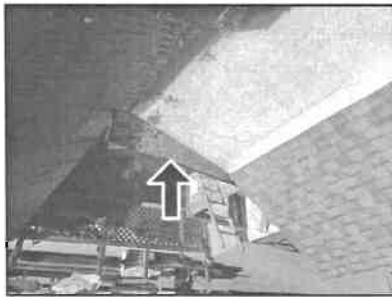
2.0 Item 5 (Picture)

(3) Slope technically insufficient for roofing material. Noted at the rear of the roof over the closet. This condition may be conducive to leaking depending on the type of installation. The inspector cannot ascertain the type of installation. At the time of the inspection no evidence of leaks were noted. It is recommended however, that a qualified Roofing Contractor review the application.

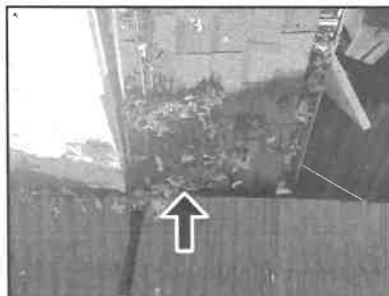
2.0 Item 2 (Picture)

the inspection. Recommend removing all debris from the roof.

(1) Clean debris from roof. Excessive debris on the roof can prevent proper drainage and limits

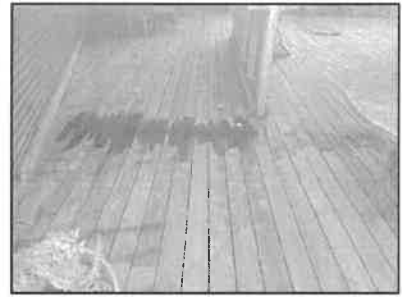
2.2 Item 2 (Picture)

(1) Gutters and drain lines are needed to help remove the water away from the deck. Noted on the rear patio of the roof. It is recommended that all water be channeled or directed away from the home.

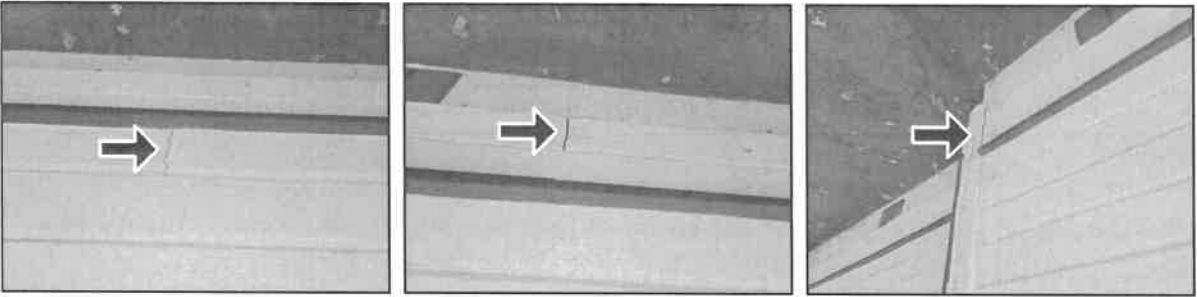
2.6 Item 5 (Picture)  
 2.6 Item 6 (Picture)  
 2.6 Item 7 (Picture)

(2) Caulking recommended on various areas of the exterior of the home. Recommend caulking, sealing and painting all gaps, voids and cracks as needed. Caulking and sealing will help prevent moisture from entering into siding and trim.

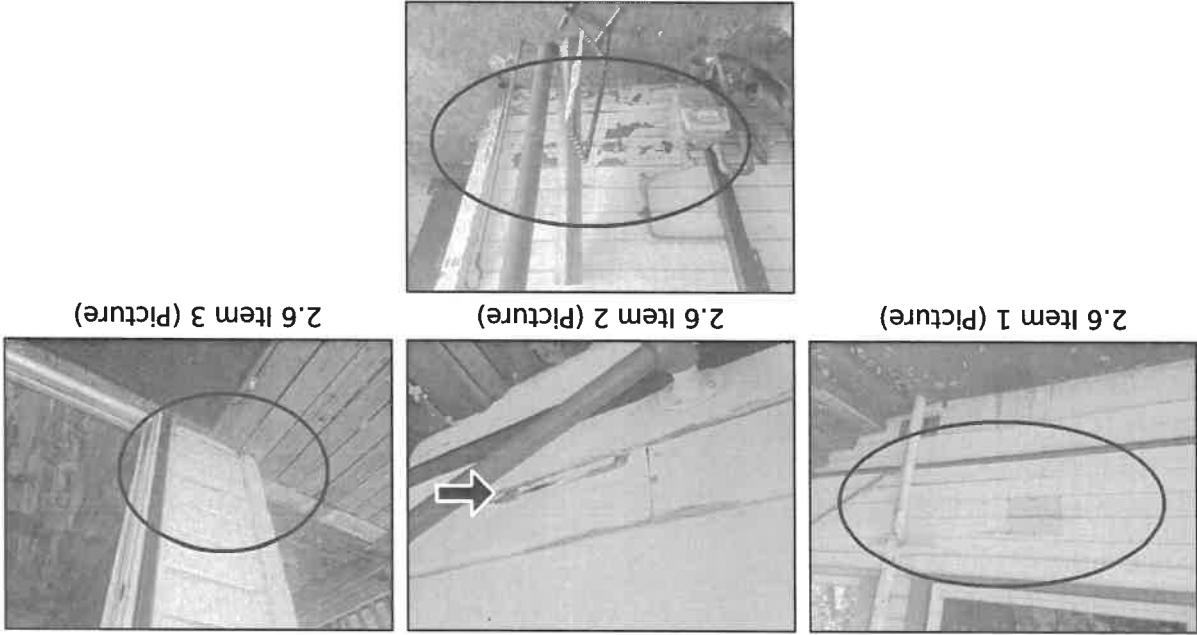
2.6 Item 1 (Picture)  
 2.6 Item 2 (Picture)  
 2.6 Item 3 (Picture)  
 2.6 Item 4 (Picture)

(1) Paint maintenance recommended. Various areas of the paint is peeling and in need of maintenance. Repairing peeling paint will help protect your home. Recommend all peeling paint be scraped and properly painted.

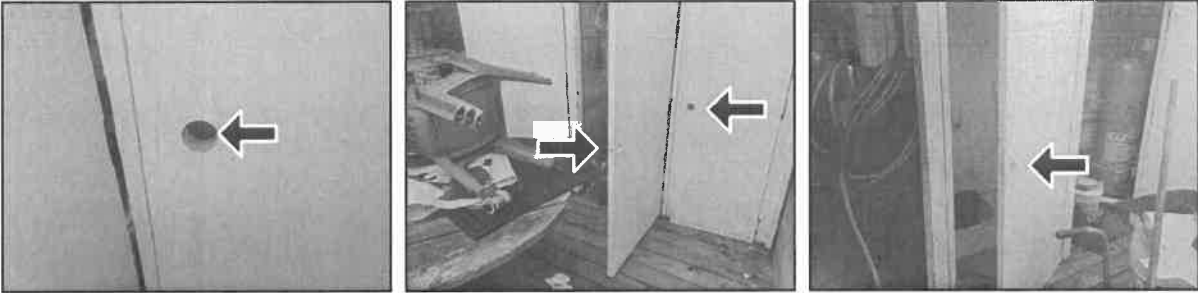
2.4 Item 1 (Picture)      2.4 Item 2 (Picture)      2.4 Item 3 (Picture)

(1) The lock-sets are missing on the rear exterior closet doors. Recommend further evaluation and repair as necessary.

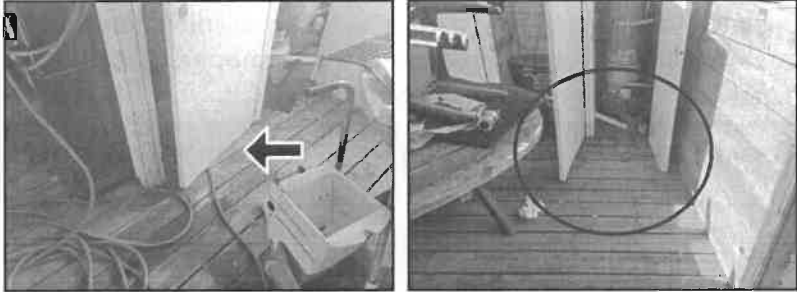
2.4 Item 4 (Picture)      2.4 Item 5 (Picture)

(2) The exterior closet doors on the rear of the home is weathered. Recommend the door be repaired.

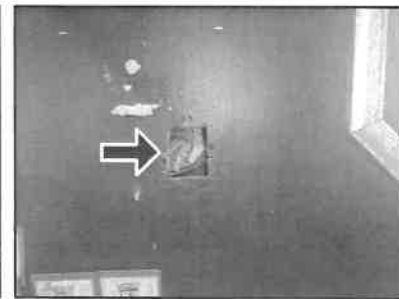
5.4 Item 5 (Picture)

(2) Junction box cover plate missing. Noted in the bar area and sub-area. Junction box cover plates are required to prevent accidental contact with the splice and to confine heat in the event of an overheated splice. Recommend repair as soon as possible. There may be others missing junction box covers that were not located. It is recommended that the finding be reviewed, and corrected as needed, by a qualified licensed contractor. A qualified licensed electrical contractor should correct as needed.

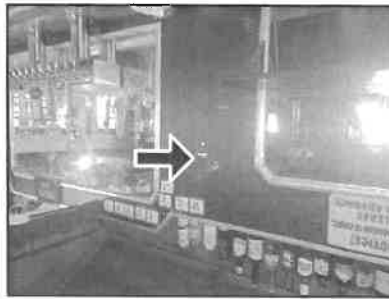
5.4 Item 7 (Picture)

(1) Junction box not installed as required (exposed splice). Noted in the attic space and sub-area. Junction box's are required to prevent accidental contact with the splice and to confine heat in the event of an overheated splice. Recommend repair as soon as possible. There may be others missing junction boxes that were not located. It is recommended that the finding be reviewed, and corrected as needed, by a qualified licensed electrical contractor before purchasing the property.

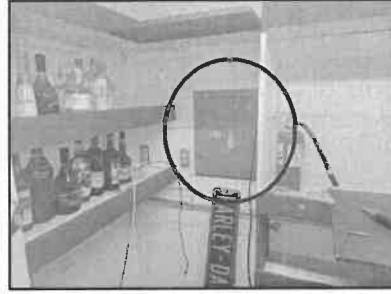
5.1 Item 3 (Picture)

(2) Electrical panel screws that secure the front cover have pointed ends. This was noted on the sub-panel. The screws should have non pointed ends. The pointed ends can damage wires in the panel. Recommend the correct screws be installed before the close of escrow.

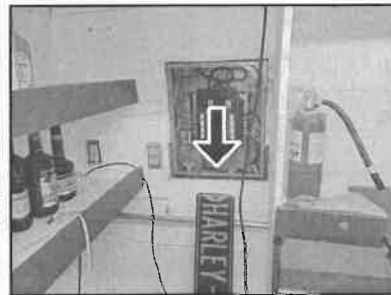
5.1 Item 5 (Picture)

(3) There are exposed holes in the sub-panel. All openings in electrical panels should not be open and should be filled with listed manufactures covers designed for the purpose. Recommend further evaluation and repair as necessary.

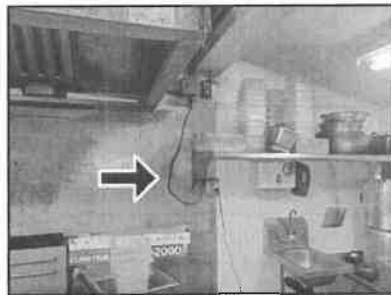
5.3 Item 2 (Picture)

Wiring not secured. Noted in the kitchen and the sub-area. Recommend securing all wiring as needed. Sections of the sheathing is damaged in the sub-area on the electrical wiring. A qualified licensed electrical contractor should correct as needed

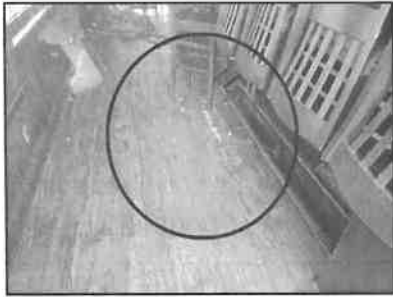
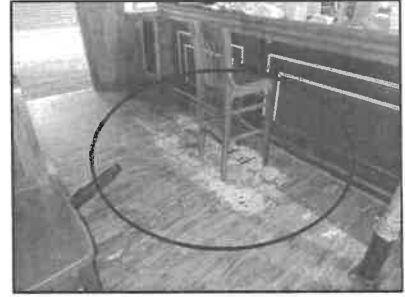
7.1 Item 1 (Picture)

(1) Wood flooring is worn / loose / gapped and in poor condition. Noted in the building at several locations. Recommend a flooring contractor further evaluate the floors and repair or replace the flooring as necessary.

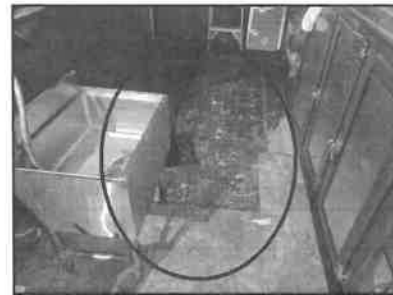
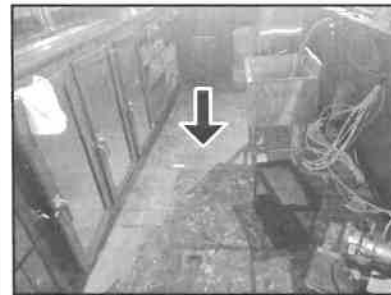
7.1 Item 7 (Picture)

(3) "Vinyl" flooring damaged and has open seams. This was noted in the bar area. Recommend a flooring contractor further evaluate the floors.

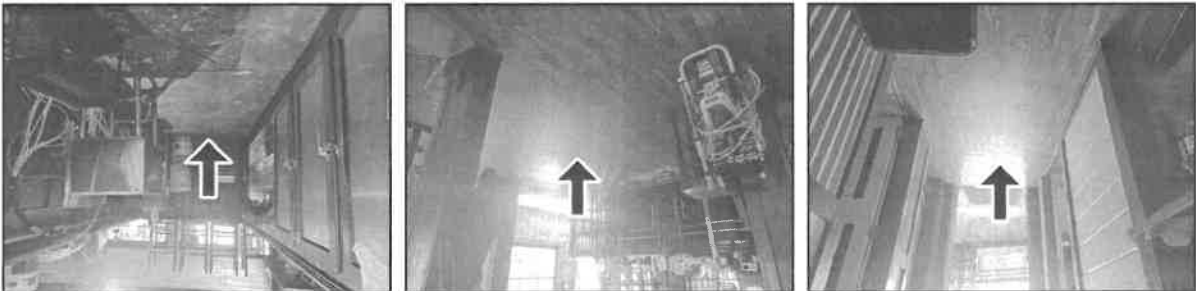
**7.2 DOORS (REPRESENTATIVE NUMBER)**

Door trim is missing on the inside of the storage room. Recommend further evaluation and repair as necessary.

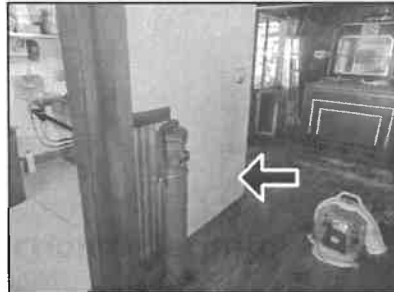
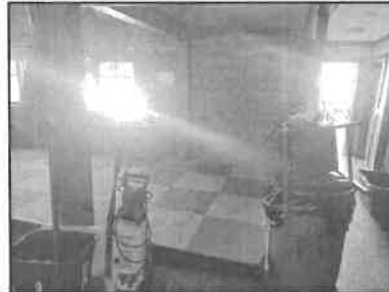
7.4 Item 3 (Picture)

(2) There is no carbon monoxide (CO) detector(s) found in the building. Recommend installing a carbon monoxide detector where necessary.

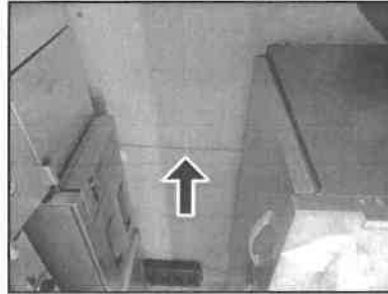
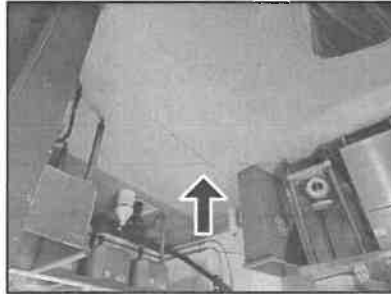
8.4 Item 2 (Picture)

The vinyl kitchen floor is lifting on the seams. Recommend further evaluation and repair by a qualified licensed flooring contractor.

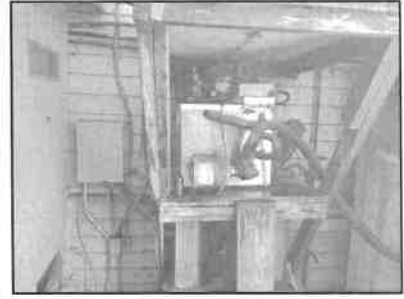
**8.5 Item 2 (Picture)**

The walk in refrigerator was not inspected or tested. Recommend further evaluation.

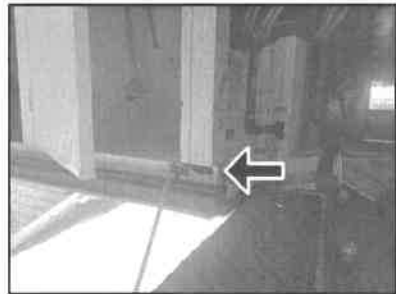
9.1 Item 1 (Picture) (1) Wood deterioration is noted in the rear closet framing and siding. Recommend refer to pest inspection or a licensed Contractor for further information concerning all possible areas with dry rot, pest or fungus damage.

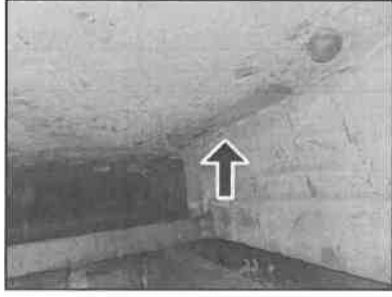
(1) Cellulose debris (scrap wood ect.) present in sub-area. Recommend removing all scrap wood

from the sub-area.

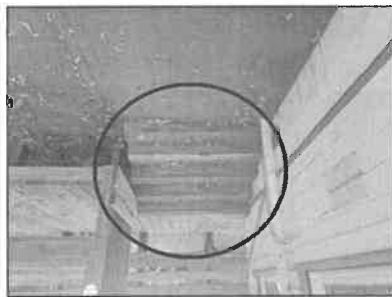
1.1 Item 1 (Picture)

Exterior stairway height varies more than 3/8 of an inch. Noted on various stairs around the home. Improper rise or run was noted at the stairs. This means that one or more of the stairs was higher or longer than the others or that the length of the stairs does not meet current standards. This should be considered a tripping hazard and correction is recommended.

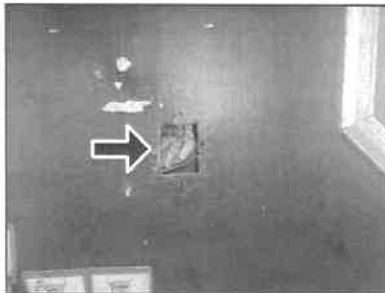
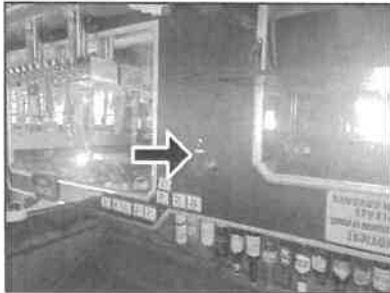
5.4 Item 6 (Picture)

overheated splice. Recommend repair as soon as possible. There may be others missing junction boxes that were not located. It is recommended that the finding be reviewed, and corrected as needed, by a qualified licensed electrical contractor before purchasing the property. (2)

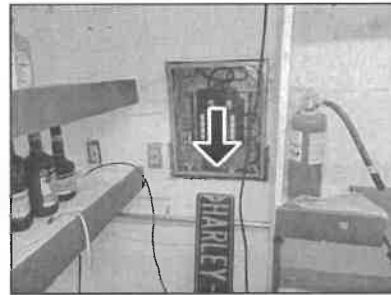
5.1 Item 5 (Picture)

There are exposed holes in the sub-panel. All openings in electrical panels should not be open and should be filled with listed manufacturers covers designed for the purpose. Recommend further evaluation and repair as necessary.

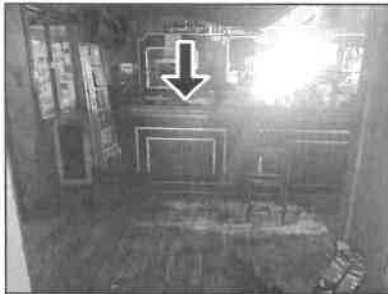
7.0 Item 1 (Picture)

The bar has damage. The bar is not properly secured and is loose when pressure is applied. Dry-rot damage is noted on areas of the bar.

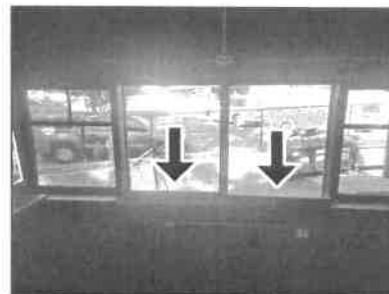
7.3 Item 1 (Picture)

Counter balance damaged on window(s) on the stage. Recommend the windows be repaired or replaced as needed. Damaged counter balance can cause the window to drop. Recommend repair as soon as possible.

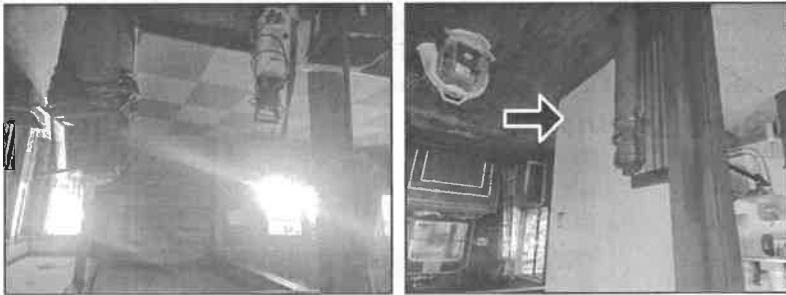
7.4 Item 3 (Picture)

There is no carbon monoxide (CO) detector(s) found in the building. Recommend installing a carbon monoxide detector where necessary.

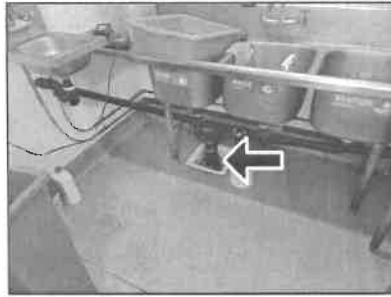
8.3 Item 1 (Picture)

The sink drain does not have the proper air gap installed. Recommend further evaluation and repair by a qualified licensed plumbing contractor.

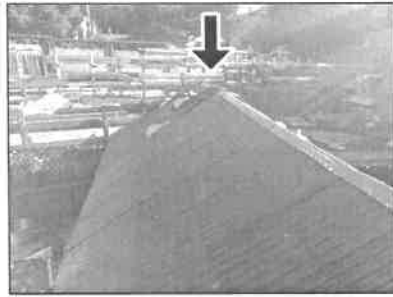
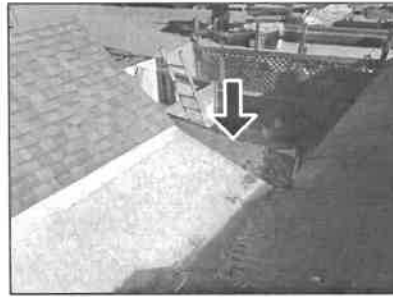
2.0 Item 4 (Picture)

Several tarps and sand bags are noted on the rear patio roof. Recommend further evaluation and repair as necessary.

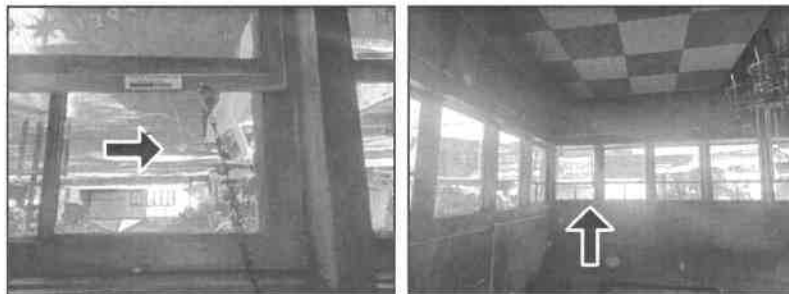
2.5 Item 1 (Picture)

Window glass is cracked. Noted on the front of the building. Recommend a qualified person repair or replace the glass.

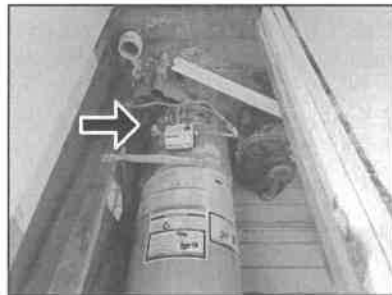
4.0 Item 3 (Picture)

Pilot light off at water heater. ASHI Standards of Practice and our E&O insurance does not allow us to turn on gas or water valves that are turned off or light pilot lights. Recommend the gas valve be turned on and pilot lights lite and have the water heater further evaluated.

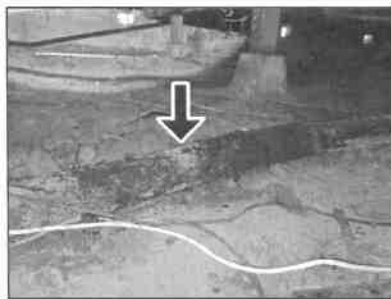
4.3 Item 1 (Picture)

The beer line in the sub-area from the walk in refrigerator to the bar is not properly secured and is laying on the ground. Recommend further evaluation and repair as necessary.

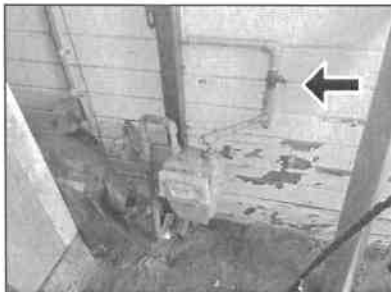
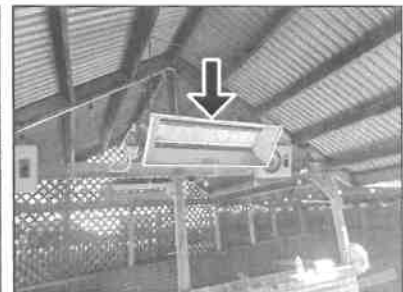
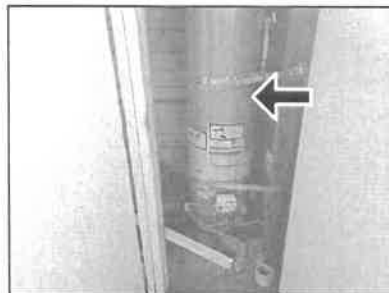
Access impaired. The gas was turned off at the time of the inspection. Various appliances and components could not be inspected due to no gas. ASHI Standards of Practice and our E&O insurance does not allow us to turn on gas valves that are turned off. Recommend PG&E turn the gas on and

inspect all gas appliances. Recommend further evaluation by a qualified plumber or gas company representative further inspect and evaluate all the gas appliances before the contingency release period.

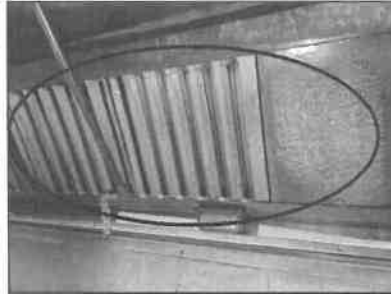
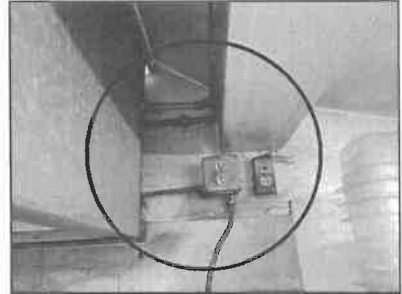
Exhaust fan / screen needs cleaning. Excessive grease is noted in the exhaust fan and around the fan on the walls and ceilings. Repair, alteration or replacement usually improves the efficiency of the component or system.

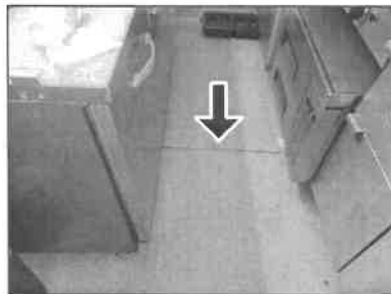
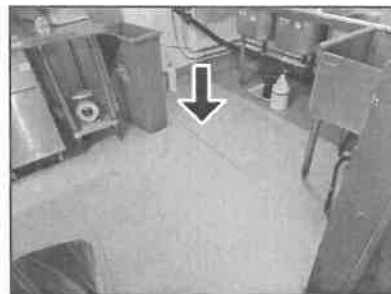
The vinyl kitchen floor is lifting on the seams. Recommend further evaluation and repair by a qualified licensed flooring contractor.

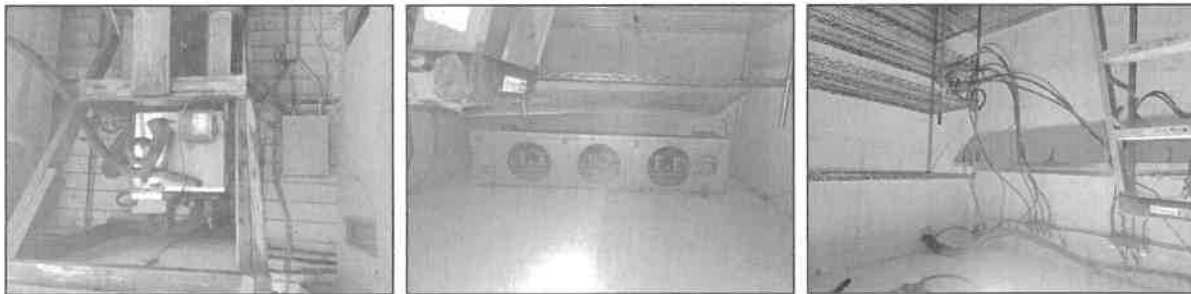
8.5 Item 1 (Picture)  
8.5 Item 2 (Picture)  
8.5 Item 3 (Picture)  
The walk in refrigerator was not inspected or tested. Recommend further evaluation.

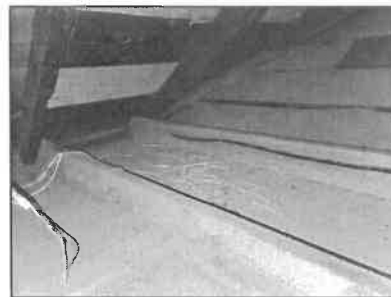
9.5 Item 2 (Picture)

Rodent activity noted. We do not determine if the activity is old or new. Evidence of rodent activity was noted in the attic. You may desire to have treatment carried out by a licensed exterminator.

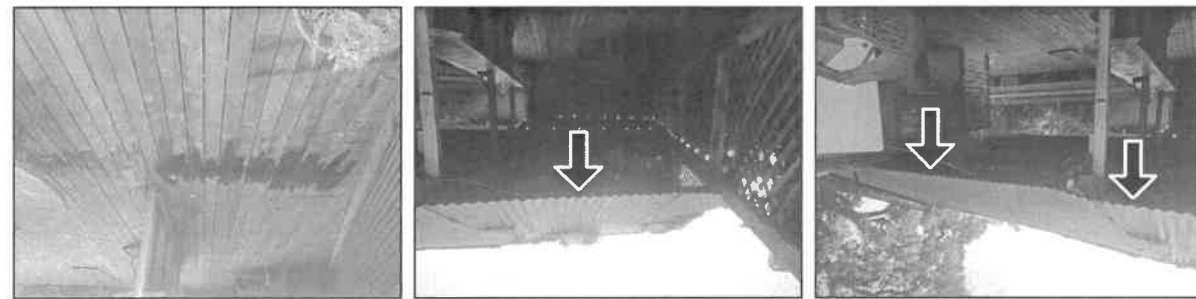
Gutters and drain lines are needed to help remove the water away from the deck. Noted on the rear patio of the roof. It is recommended that all water be channeled or directed away from the home.

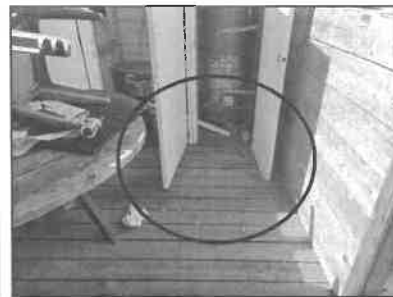
2.4 Item 5 (Picture)

The exterior closet doors on the rear of the home is weathered. Recommend the door be repaired.

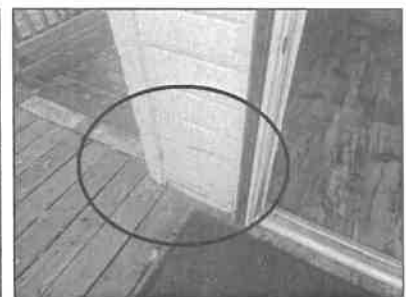
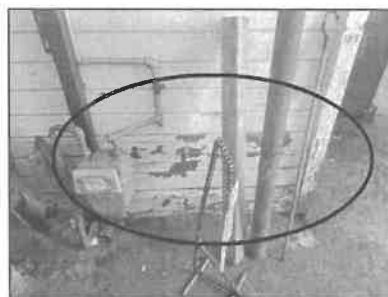
Paint maintenance recommended. Various areas of the paint is peeling and in need of maintenance. Repairing peeling paint will help protect your home. Recommend all peeling paint be scraped and

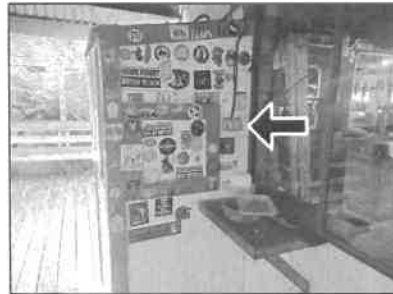
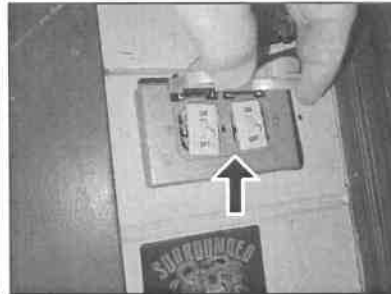
Switch purpose unknown. Refer to property owner if possible. Noted on the rear exterior of the building.

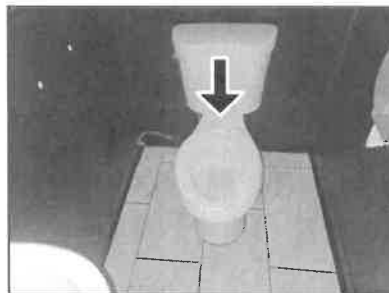
6.0 Item 1 (Picture)

The toilet lid is missing in the women's bathroom. Recommend further evaluation and repair as necessary.

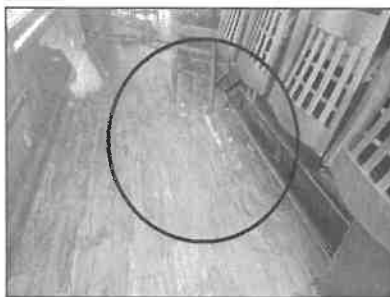
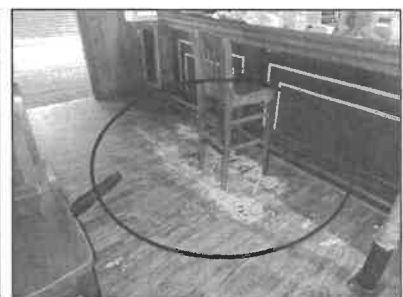
Wood flooring is worn / loose / gapped and in poor condition. Noted in the building at several locations. Recommend a flooring contractor further evaluate the floors and repair or replace the flooring as necessary.

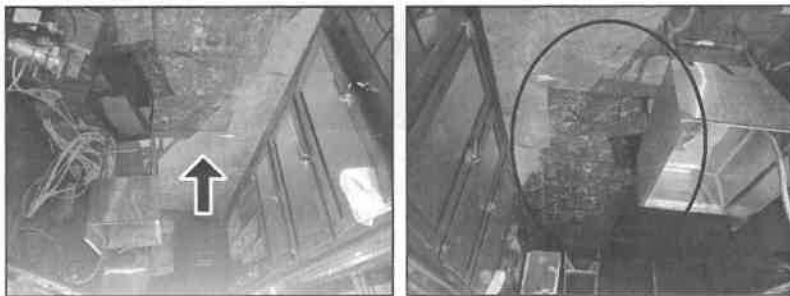
"Vinyl" flooring damaged and has open seams. This was noted in the bar area. Recommend a flooring contractor further evaluate the floors.

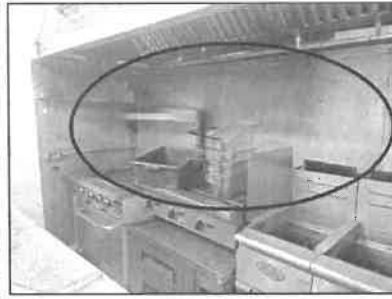
8.0 Item 3 (Picture)

The metal backsplash around the range and fryers is not stainless steel. Recommend further evaluation and repair / replacement as necessary.

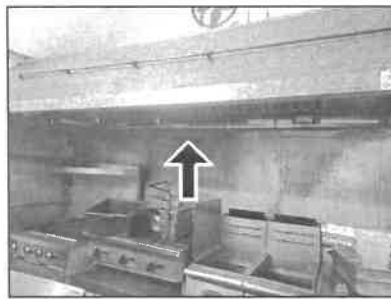
8.1 Item 7 (Picture)

Exhaust fan inoperative. It is recommended that the finding be reviewed, and corrected as needed, by a qualified technician before purchasing the property.

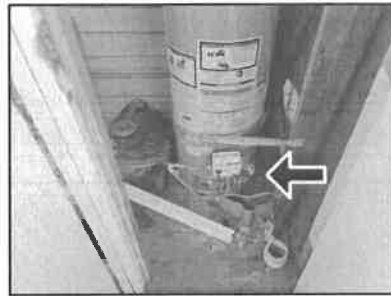
4.0 Item 3 (Picture)

(2) Pilot light off at water heater. ASHI Standards of Practice and our E&O insurance does not allow us to turn on gas or water valves that are turned off or light pilot lights. Recommend the gas valve be turned on and pilot lights lite and have the water heater further evaluated.
